## Typical wear mechanism of 2-stroke exhaust valves

Marine Propulsion conference 2004

*Dr. Ing. Holger Fellmann, Head of 2-stroke department & service; Märkisches Werk GmbH  
Thomas Groß, Head of development department; Märkisches Werk GmbH  
Torsten Ludwig, Head of marketing department; Märkisches Werk GmbH*

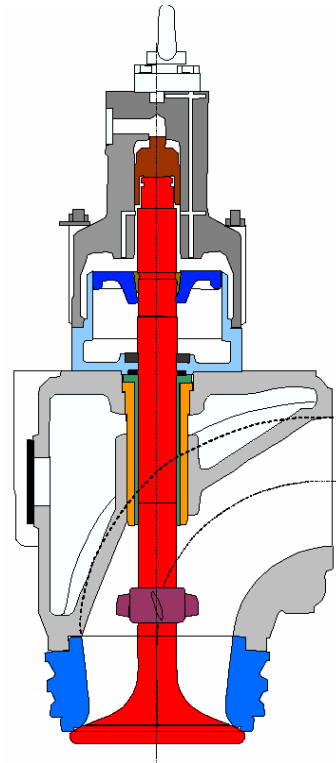
- Valve drive or hydraulic actuator
- Air cylinder
- Valve housing
- Valve guide
- Valve spindle
- Bottom piece or seat ring

Figure 01:  
Main components of an  
exhaust valve

The design of the exhaust valves of all three engine builders are different in details, but the general function is the same, see figure-O 1. The main components of MC, RTA and UEC are:

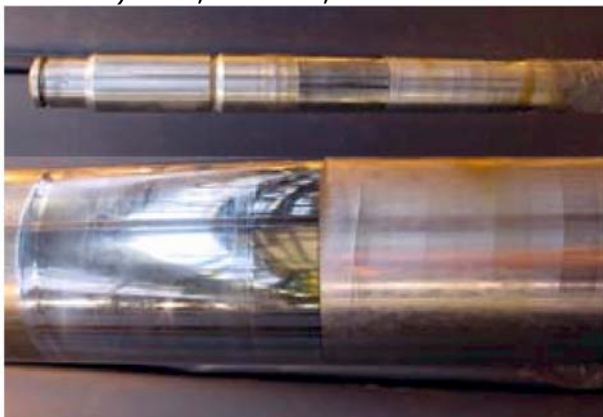
Figure 02:  
*Physical adhesion and abrasive wear of a hard chromed valve spindle (MC-type after 15,000 hrs)*

Adhesion and abrasive wear is very often found in the stem sealing area of hard chromed, MC valve spindles (see figure 02). Usually the limit of this stem diameter is reached after 12,000 - 18,000 hrs. MC valve spindles with HVOF-stem coating, as well as RTA- and UEC valve spindles with hard-chromed stems, reach a TBO (time between overhaul) of 24,000 - 36,000 hrs.

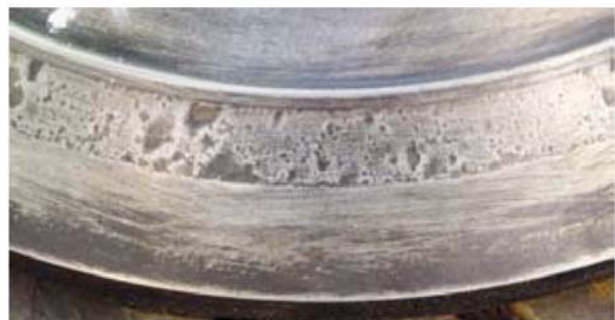
Figure 03:  
*Typical dent marks of the seat of a valve spindle (MC60-type Nimonic after 8,300 hrs)*

Together with high seat pressure and a higher seat hardness of the bottom piece, the MC-type shows the highest probability and intensity of dent marks with TBOs of 6,000-18,000 hrs (see figure 03). The seats of RTA- and UEC-types require overhauls after 12,000 - 36,000 hrs.

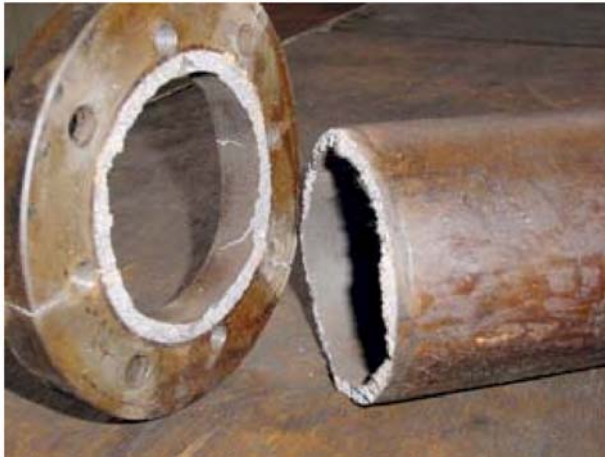
Figure 04a:  
Breakage of the valve guide during valve spindle disassembling

To disassemble exhaust valves, hydraulic power is usually necessary to remove the valve spindle from the valve guide. In some cases the sticking of the valve spindle is so extreme that the valve guide breaks during the operation (see figure 04a and 04b).

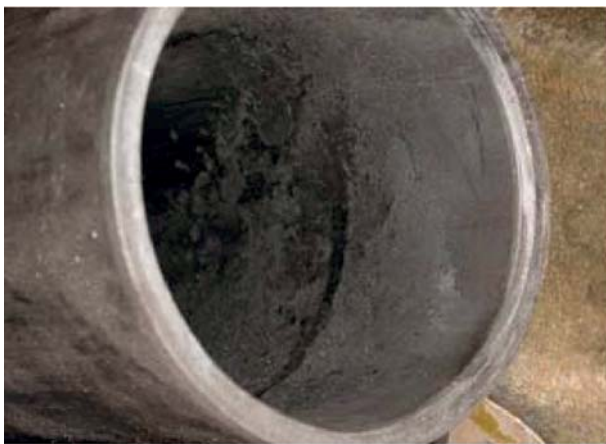
Figure 04b:  
Typical deposits of inner diameter of valve guide (MC70-type after 8,200 hrs)

Depending on the design of the valve guide, its inner diameter will display more or less deposit build up. Exhaust gas enters into the clearance between valve spindle stem and the inner diameter of the valve guide, which allows deposits inside the guide (see figure 04). Due to this, MC-types need a replacement of the valve guide between 6,000 - 8,000 hrs to minimize the risk of the valve spindle sticking in the guide.

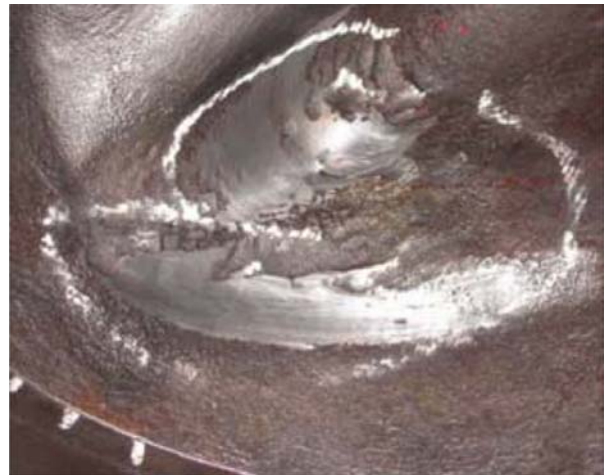
Figure 05:  
Low temperature corrosion of valve housing (MC-type 43,700 hrs)

Nearly all components of the exhaust gas channel show some low-temperature corrosion (see figure 05-07).

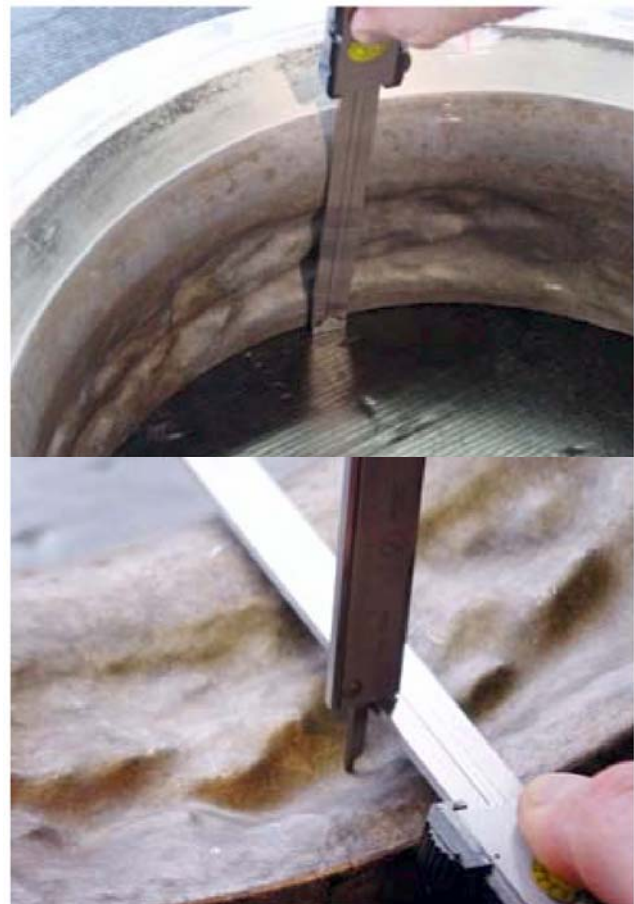
Figure 06:  
Low temperature corrosion of bottom piece (RTA-type after 28,420 hrs)

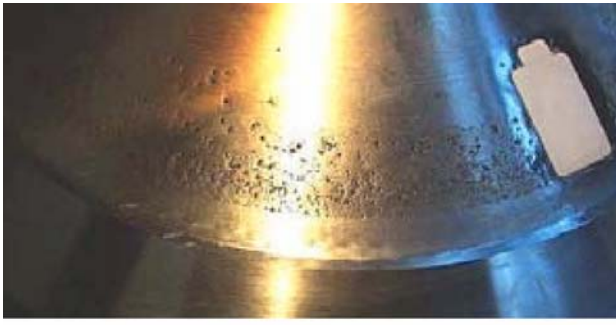
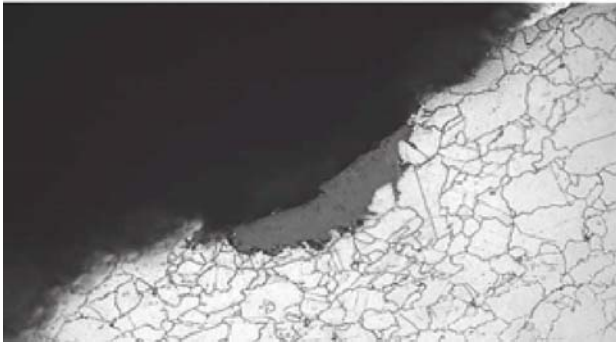
Figure 07: Low temperature corrosion ( pitting corrosion Attack) of under head radius of valve spindle (MC60-standard/22.700hrs)

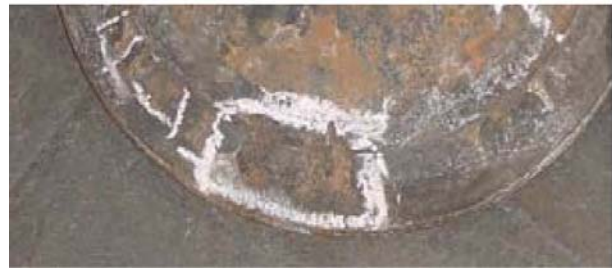
Figure 08: "Cobble stone corrosion" appearance of valve spindle failure through high-temperature corrosion (MC60 Standard-type)

This can lead to crucial micro gas channels, which will grow over the time (NANDA, 2003). Because of the high temperature, the salt deposits reach their melting point, then the "cobble stone corrosion" starts (see figure 08) at the seat and finally leads to blow-byes (UMLAND 1975, RITZKOPF 1975).

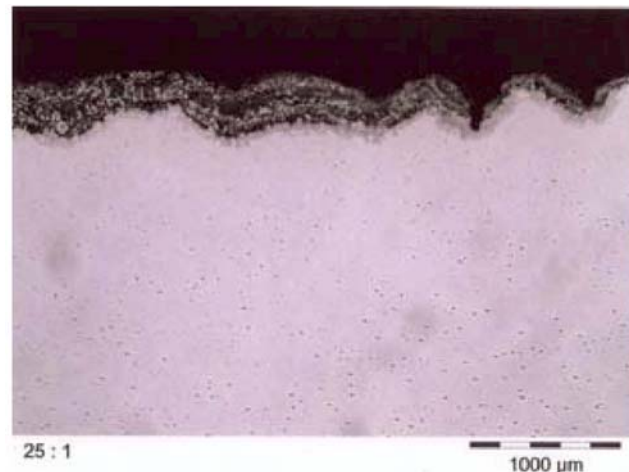
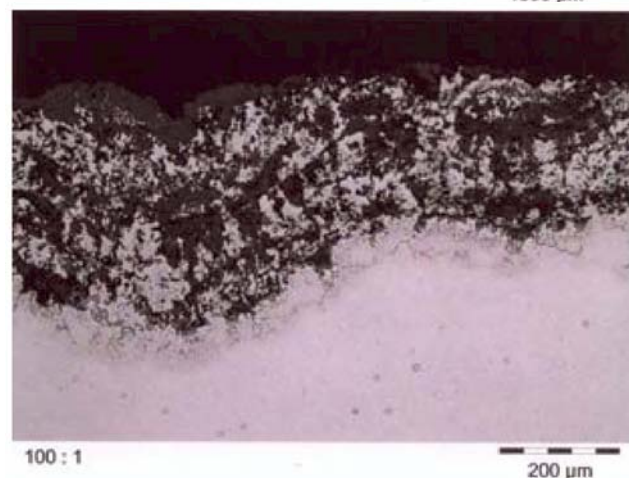
Figure 09: Micro cuts of Nimonic with high-temperature corrosion.

The bottom of the valve spindle is mostly operating in the critical area of the high-temperature corrosion seen as "cobble stone corrosion". The wear rate is between 0,2 - 1,0 mm / 1,000 hrs. depending on valve material and type of engine. The limit for remanufacturing is only reached after 12 mm. This leads to a TBO of about 12,000 - 60,000 hrs. Figure 09 shows micro cuts of Nimonic with high-temperature corrosion.

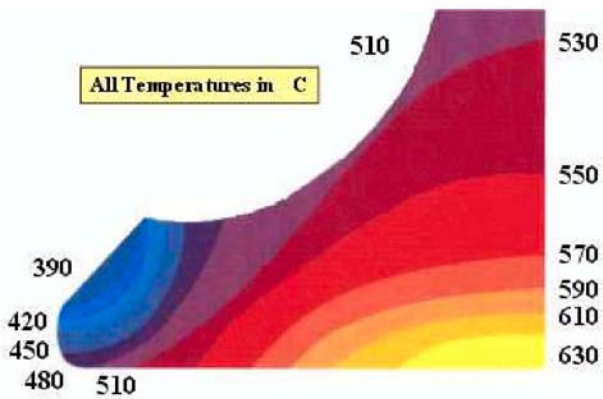
Figure 10:  
Typical temperature distribution of a Nimonic exhaust valve head

The valve spindle is the component with the maximum thermal stress. Most of fatigue problems are documented at the valve spindles. Figure 10 demonstrates a typical heat distribution across a Nimonic valve head.

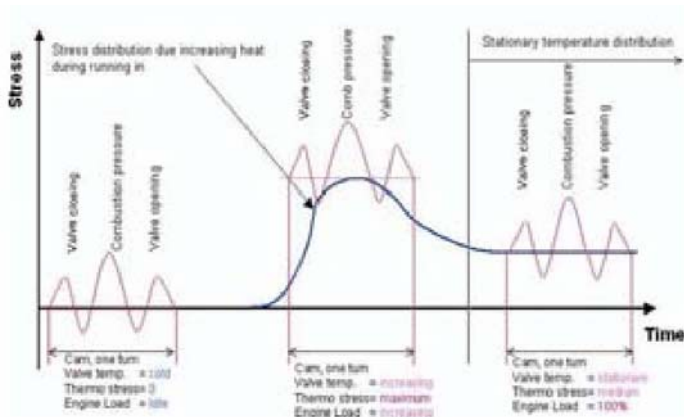
Figure 11:  
Mechanical and thermal load as function of running in and stationary operation

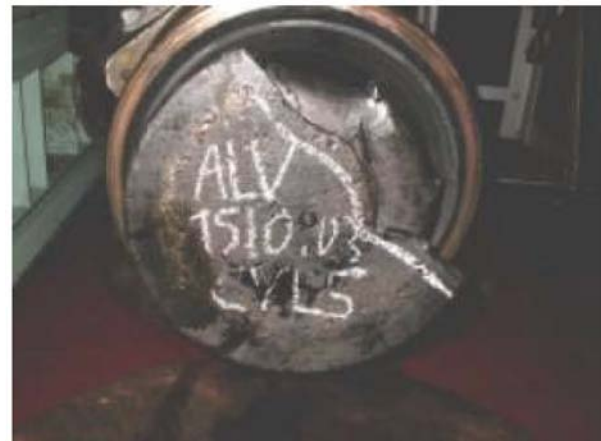
Figure 12:  
Catastrophic failure of a repaired valve spindle (RTA 72 Nimonic-type 740 hrs after repair)

There are two typical failure reasons. One is a crack that starts in the under head radius. After the micro cracks get to a critical length, the speed of the crack growth increases. A catastrophic failure follows, with parts of the spindle dropping down into the combustion chamber (see figure 12 and 13).

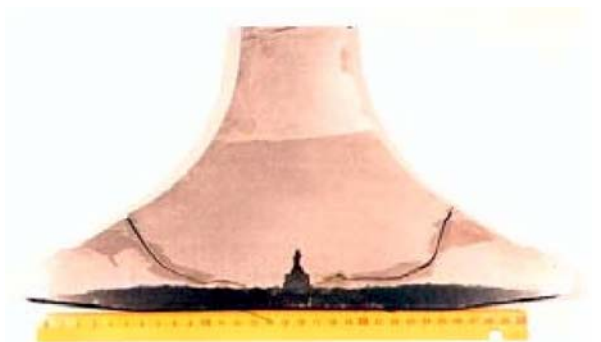
Figure 13:  
Macro cut through the center of a valve head (RTA62 Nimonic-type 6,430 hrs after repair)

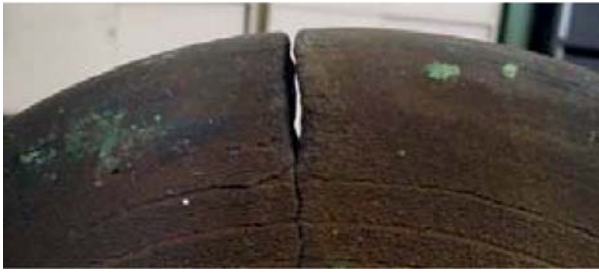
Figure 14:  
Failure of a valve spindle (RTA84 Nimonic type 5, 270 hrs after repair).

The second failure reason is: Micro cracks starting in the outer diameter of the valve bottom. After reaching the seat area blow-byes are created and the valve spindle is destroyed (see figure 14).

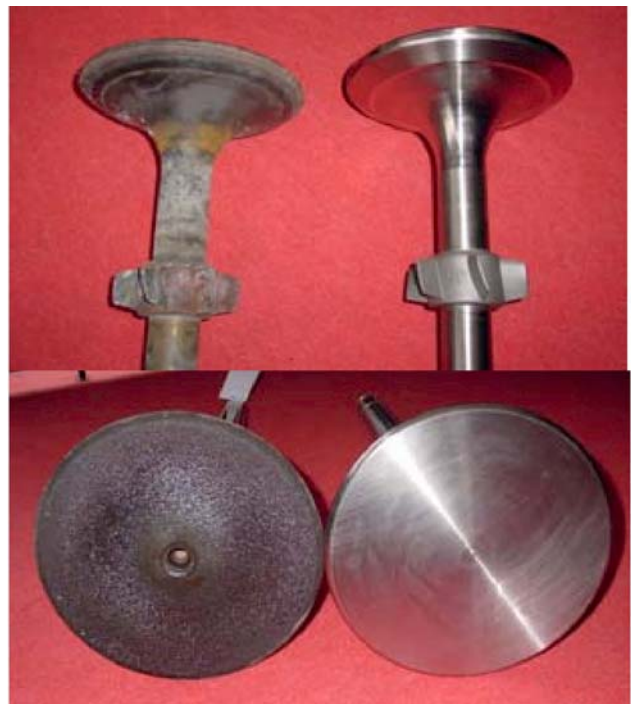
Figure 15 a/b: Nimalike spindle before and after remanufacturing

To extend the lifetime of a standard valve spindle to a lifetime similar to Nimonic, or to remanufacture Nimonic valve spindles in a way that leads to "close to new" conditions after the process (see figures 15 a/b).

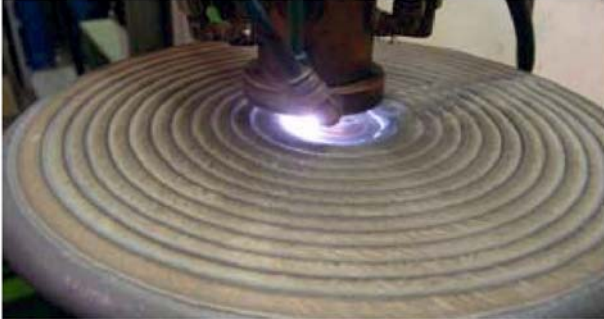
Figure 16: PTA-welding

The experience is coupled with continuous improvement of manufacturing processes and intensive R&D in the fields of metallurgy and welding processes (see figure 16).

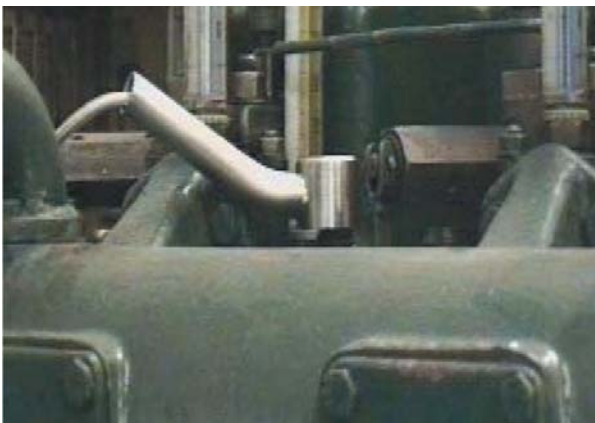
Figure 17: Leakage Measure System onboard in use

For this reason MWH provides the "Leakage Measure System", a mobile diagnostic system which is able to detect leakages at the cylinder head to prevent fatal failures of a running engine.

The principle is based on measurement of ultrasonic sound by using one simple and robust sensor (WEHNER, ALBERT 2001).

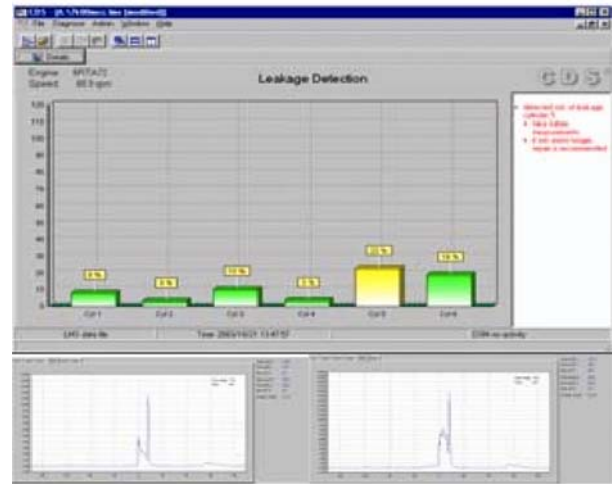
Figure 18: Documentation of the result of leakage detection and valve timing/ignition

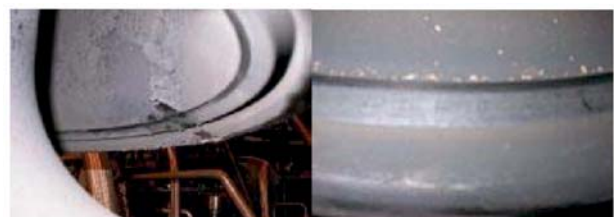
Figure 19: Seat ring and valve spindle show no dent marks after app. 1,000 hours.

The rotation also prompts a balanced temperature distribution across the entire valve head, thereby reducing thermally induced strain. First field tests are ongoing with a MC70 engine. Inspections have proven that the Turnomat® works as designed (see figure 19).
